Field Report for Airborne Data Collected In Support of US EPA Region 6 South 4 Group Fire 03 December 2019

Flight Results for Flight 12, 03 December 2019

Flight Results for Flight 13, 03 December 2019

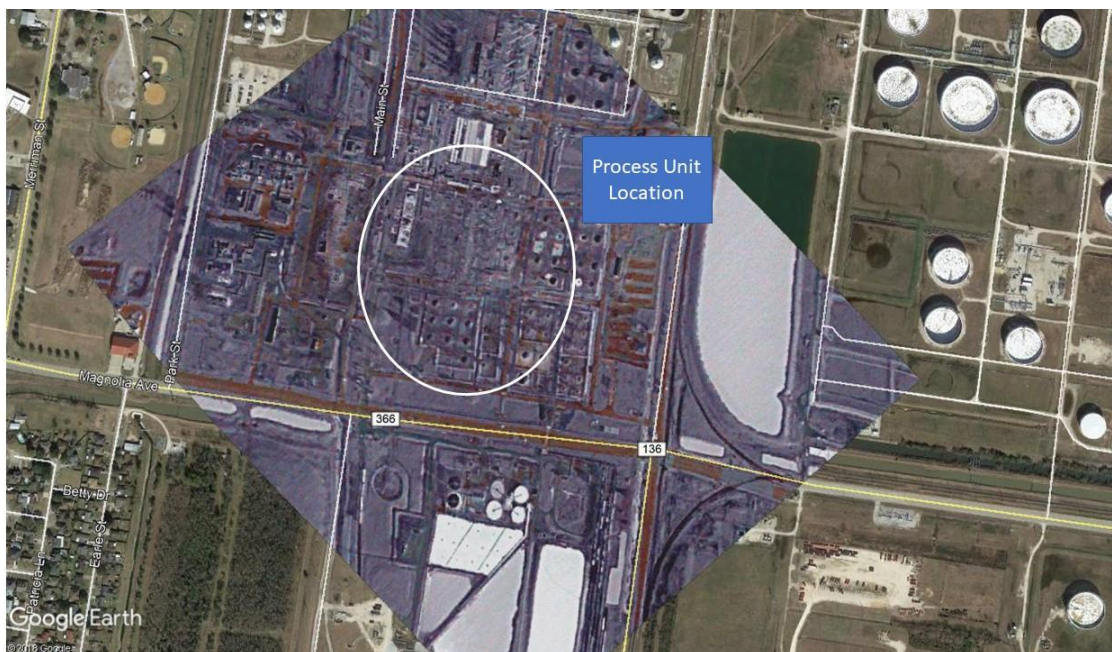
A total of 2 test and 7 data collection passes were made in the proximity of the fire and an infrared line scanner image was generated for each pass. Figure 3 shows a typical 3-band infrared image obtained from data collected for Run 3. The thermal environment of the unit is low. At the time of the IR collection, no water cannon or emissions can be seen in the image. Figure 4 shows a close-up thermal analysis of the production facility again showing a flat thermal environment in the unit.

Figure 3: – 3 band IR image, Flight 12, Run 8, South 4 Group Fire

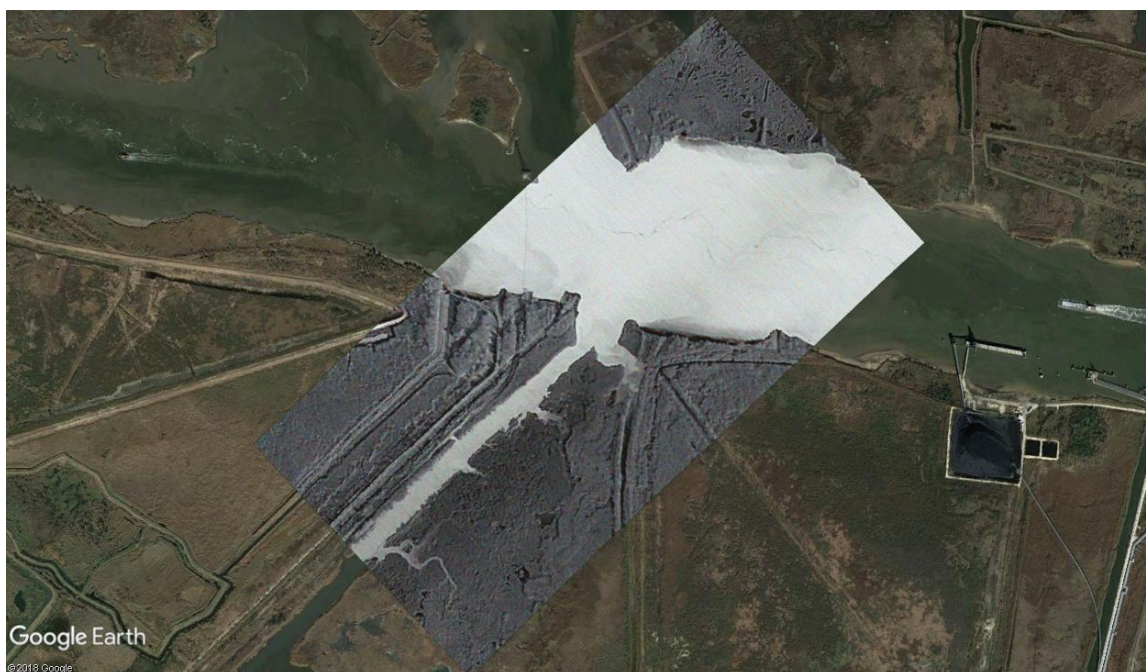
As part of the flight mission, ASPECT was flown along a waterway leading from the east side of the facility to the Naches River. Figure 5 show an IR image of the waterway flowing into the River. No sheen can be seen in the image.

Figure 5: -- 3 band IR Image, Flight 12, Run 10, Waterway Image, South 4 Group Fire

analysis of imagery. There were no chemical detections in the proximity of the facility. Analysis IR imagery of the junction of the waterway east of the facility which intersects with the Naches River showed on evidence of oil sheen.

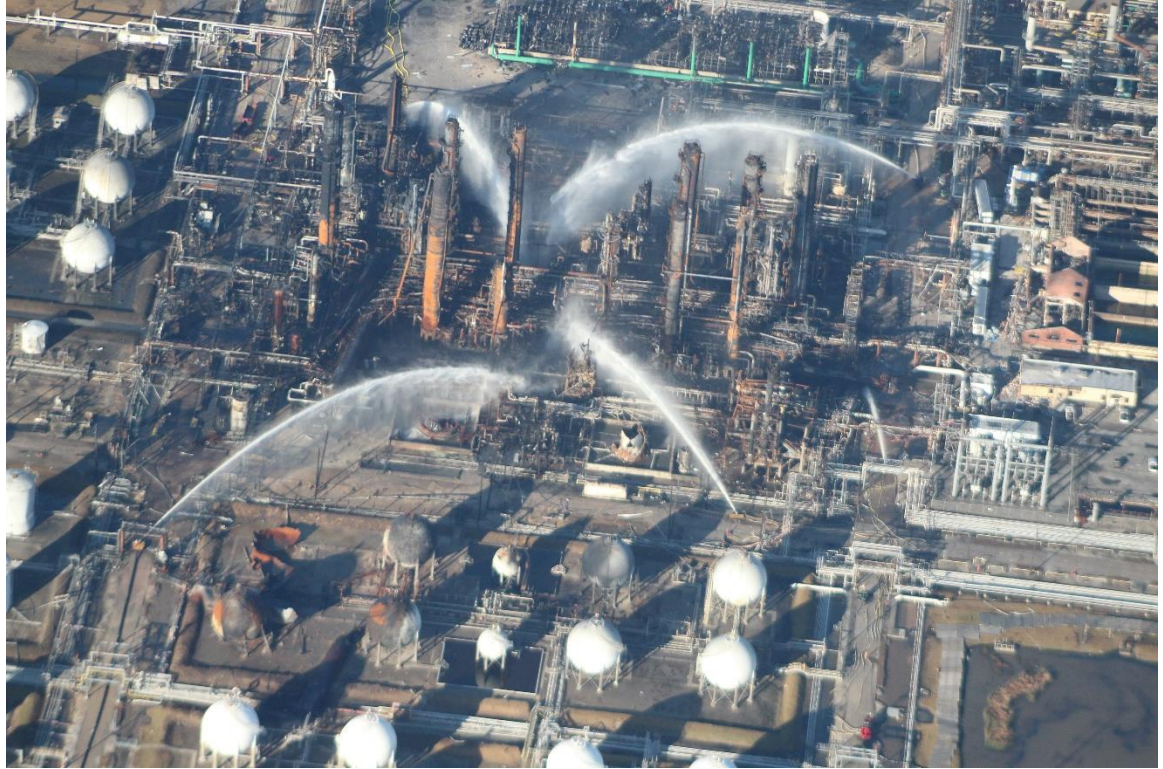
A full set of high resolution aerial digital photography were collected as part of the flight. Figure 6 shows a representative image collected as part of each pass. Smoke is not evident in the image and only one water cannon can be observed being directed into the north part of the unit. No fire was observed. The oblique image in Figure 7 shows that 5 water cannons were in operation with no evidence of fire or smoke generation.

Figure 7: Oblique Image of the South 4 Group Fire

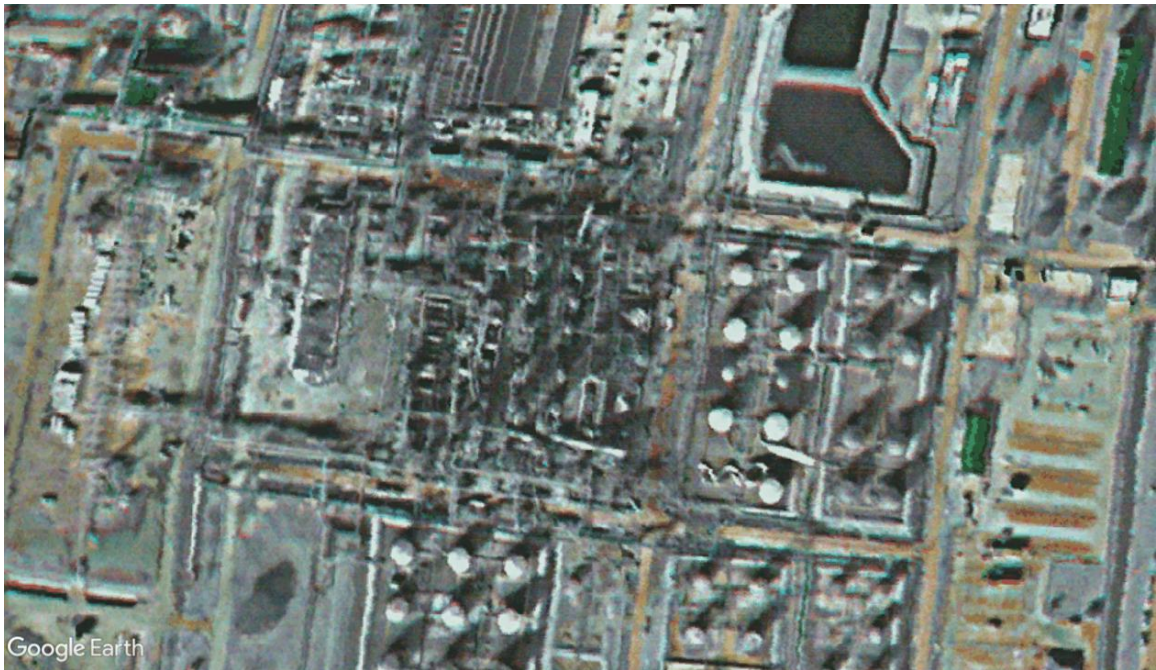
A total of 1 test and 6 data collection passes were made in the proximity of the fire and an infrared line scanner image was generated for each pass. Figure 9 shows a 3-band infrared image obtained from data collected for Run 2. Examination of the image shows no significant elevated thermal locations on this collection pass. No chemical plume was observed in the frame. Figure 10 shows a close-up of the process unit collected on Run 5. No apparent high temperature source is evident in the image.

Figure 10: -- 3 band IR image, Flight 13, Run 5, South 4 Group Fire

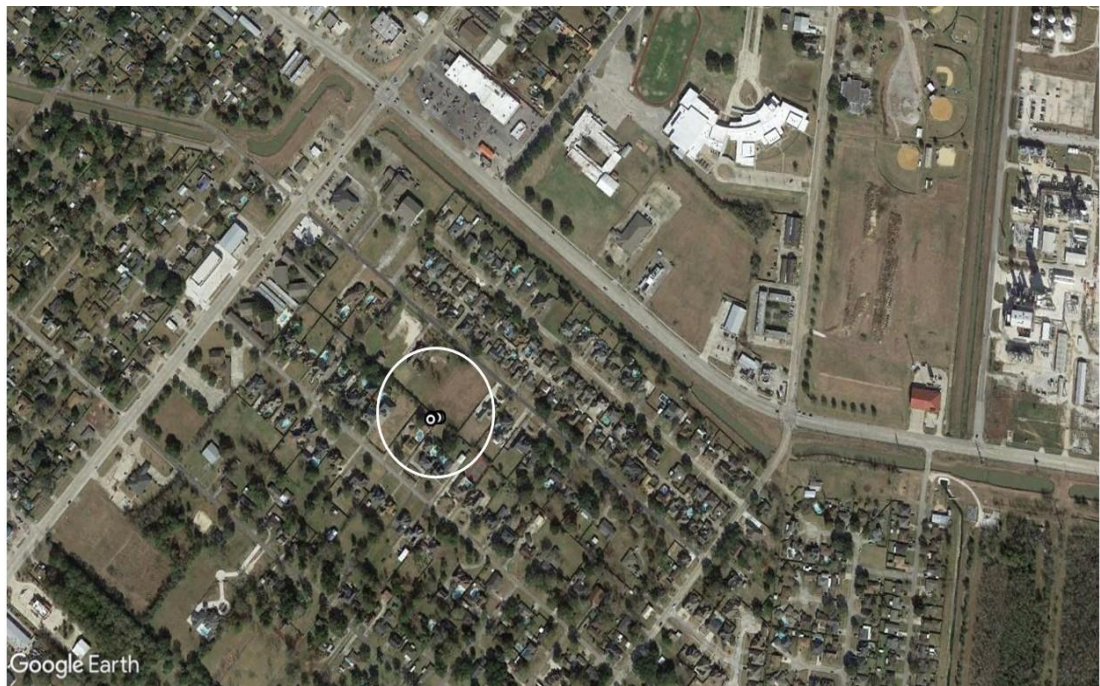
Due to reported elevated VOC levels near the community west of the facility, flight lines were extended to provide data collection over these areas approximately 1300 meters west of the facility, detections of 1,3-butadiene and aromatic hydrocarbons were detected. The location of the detection is given in figure 11. Figure 12 show a spectrum for the 1,3-butadiene detection. This is a somewhat complicated spectra since there appears to be other hydrocarbons present in the data. Within the same cluster of detection points, an aromatic such as ethyl benzene was also detected. Figure 13 shows this spectrum with strong peaks just above 700 wave numbers. Analysis of the data shows the highest concentration of 1,3-butadiene at approximately 0.9 ppm. A concentration for the aromatic is difficult since this was analyzed manually but it is estimated that the concentration is less than 1 ppm. A summary of data of the data collection is given in table 6.

Figure 11: -- 1,3-Butadiene and Aromatic Hydrocarbon Detection Locations, Flight 13, South 4 Group Fire

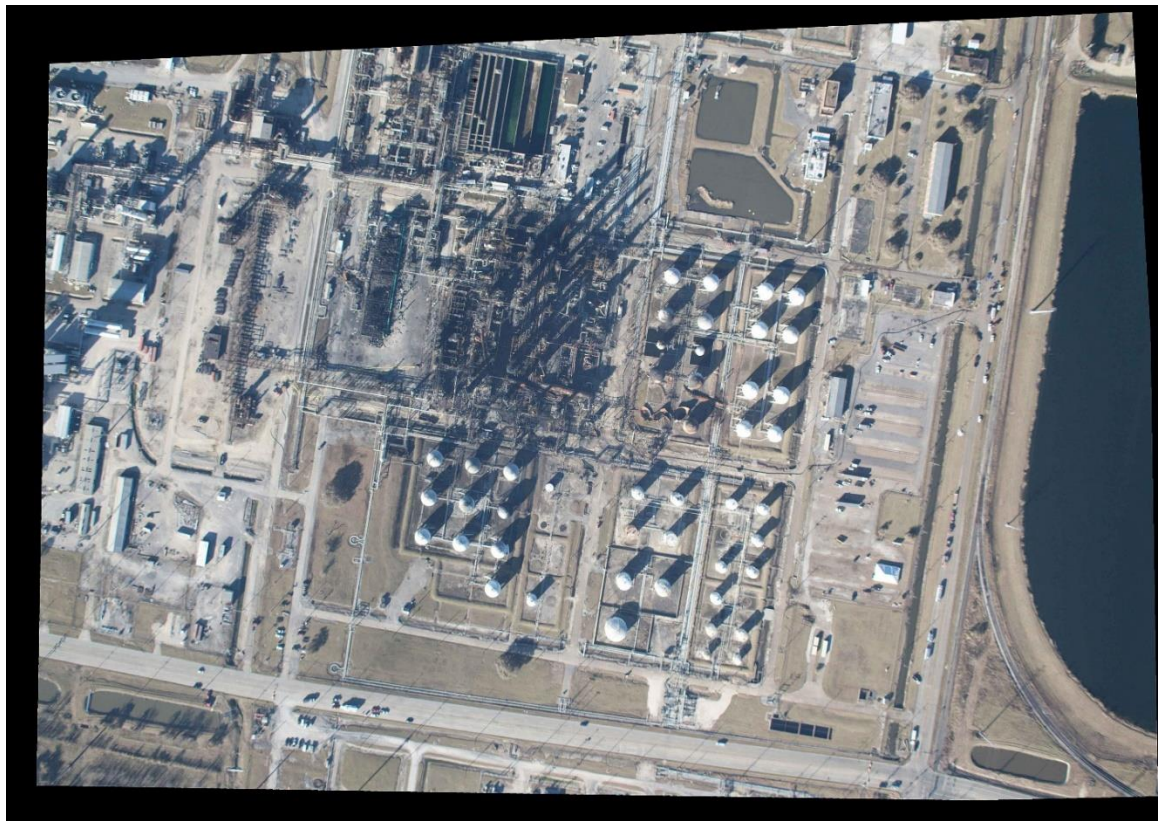
A full set of high resolution aerial digital photography were collected as part of the flight. Figure 14 shows a representative image collected as part of each pass. In a similar fashion as the morning flight no smoke was observed being emitted from the site. Oblique imagery does show that water cannons continue to be used to flood the process unit (figure 15).

Figure 14: Aerial Image of the South 4Group Fire, Flight 13

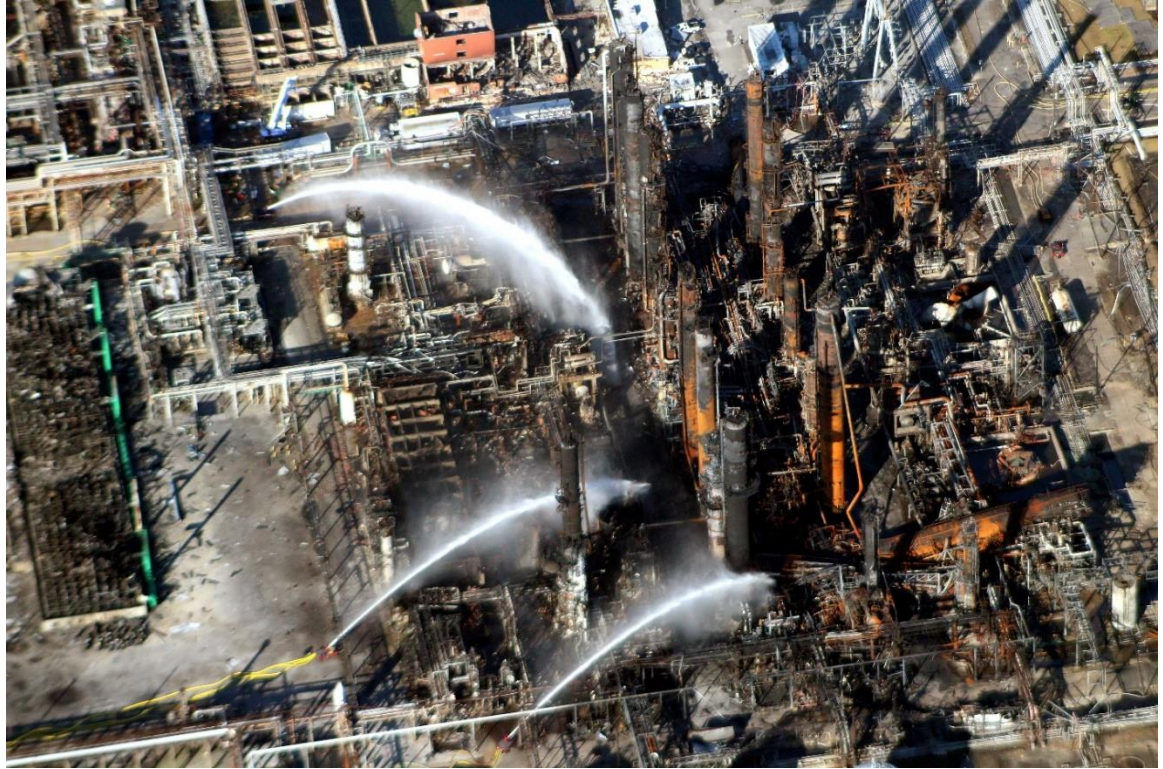
Figure 15: Oblique Image of the South 4Group Fire, Flight 13
